PAPER NO.: 14

Investigations into Abrasive and Corrosive wear mechanisms of Pistons and Liners in large bore 2-stroke diesel engine cylinders

Terence McGeary, Flame Marine Ltd, United Kingdom
terence@flamemarine.com

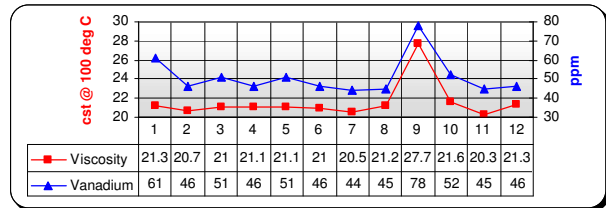
Chart 4 – Ship C (5th June 03 samples)

The high Vanadium and high Viscosity of Units 1 & 9 (Chart 4) indicate fuel contamination. And correspondingly high Iron for Units 1 & 9 seen in Chart 5 points to combustion irregularity causing higher wear.

High Viscosity and Vanadium for Unit 9 indicate fuel contamination

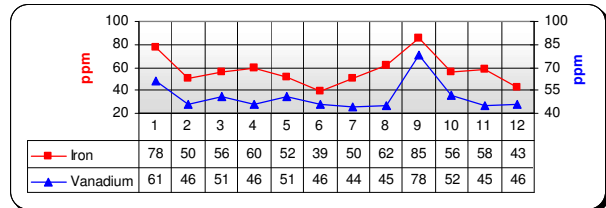
Chart 5 – Ship C (5th June 03 samples)

High Vanadium/ high Iron in Units 1 & 9 indicate that a combustion irregularity is causing an increase in wear.

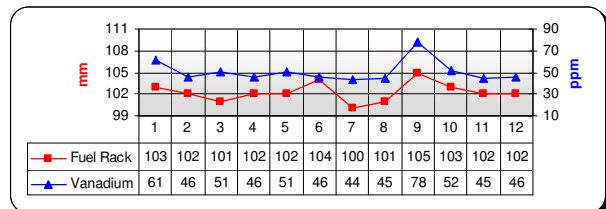
Chart 6 – Ship C (5th June 03 samples)

High Fuel Rack and Vanadium for Units 1 and 9 suggest greater amount of fuel injected

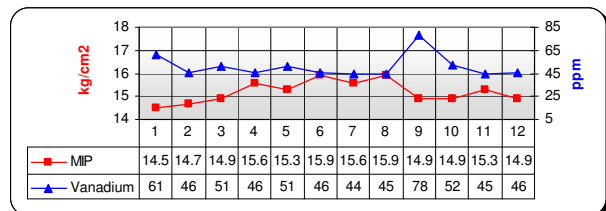
Chart 7 – Ship C (5th June 03 samples)

Chart 7 demonstrates how changes in the relationship between MIP and Vanadium can indicate even small changes in the efficiency of combustion. This assumes that the relationship between MIP and Vanadium should remain constant if the fuel injected burns completely, and that calorific value available in the fuel is effectively converted to heat energy. The MIP should then correspond with the amount of fuel injected.

A lower MIP, as compared with other cylinders with similar amount of fuel injected, would indicate, either that the fuel is not completely burned, due to defective atomisation, or the calorific value available in the fuel is not effectively converted to heat energy, due to incorrect timing or blow-by.

High Vanadium and low MIP in Units 1 and 9 indicate incomplete combustion

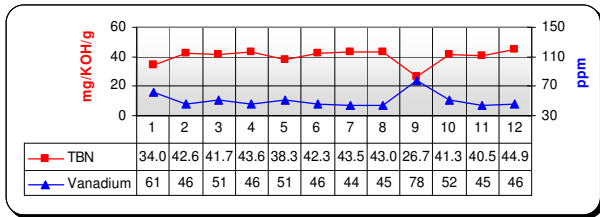
Chart 14 – Ship C (5th June 03 samples)

Chart 14 shows the effect of minor fuel contamination on TBN in Unit 1 and a greater amount of fuel contamination in Unit 9.

Contamination by fuel of the drain oil from Units 1 and 9 is diluting the TBN.

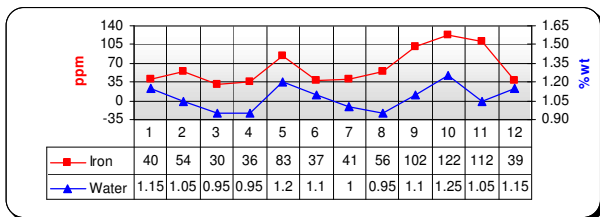
Chart 15– Ship C (8th September 03 samples)

Water is influencing Iron ppm particularly in Units 5 and 10.

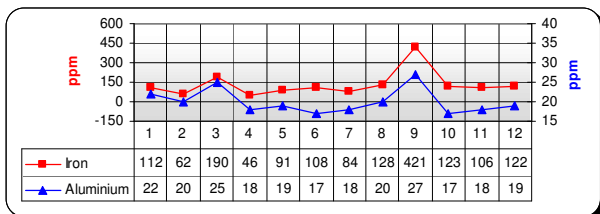
Chart 16 – Ship B (24th October 03 samples)

Cat-fines influencing Iron ppm particularly in Units 3 and 9.

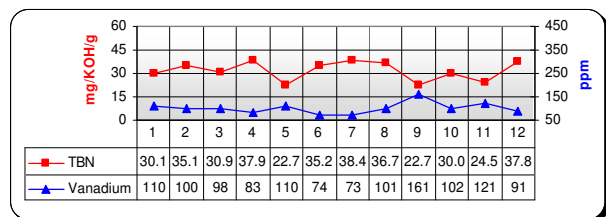
Chart 17 – Ship C (18th October 03 samples)

Dilution of the CDO by fuel contamination, or system oil leakage into the under-piston space, would give rise to a lower TBN value. Chart 17 shows that Fuel contamination is diluting the CDO in several cylinders of which Units 5, 9 and 11 are the most affected.

Fuel contamination diluting the TBN in Unit 9

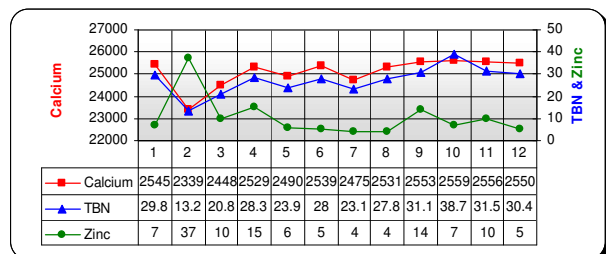
Chart 18 – Ship A (2nd October 03 samples)

Chart 18 demonstrates System oil (as indicated by Zinc) contaminating the cylinder drain oil from Unit 2 and diluting both TBN and Calcium. (Note that Calcium value of the fresh oil is 25,600 ppm)

System oil contamination diluting the TBN and Calcium in Unit 2

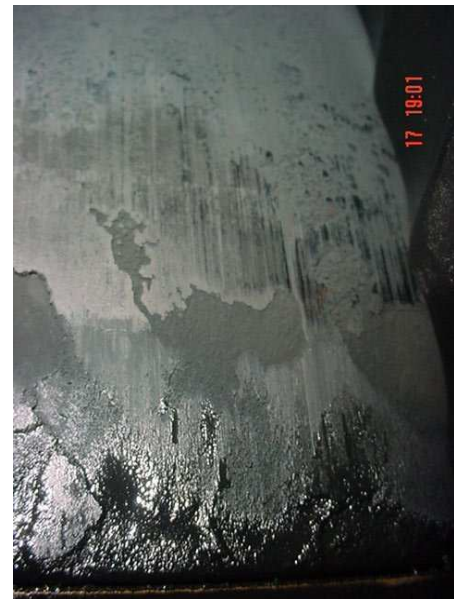
However piston skirt abrasion against the liner wall is also seen to occur whenever there is a build up of deposit on the piston topland. Abrasive wear between piston and liner wall is reported [2][6] to be due to deposits on the piston topland which disturbs the lubricant film and may cause scuffing.

Deposits on Unit 4 piston top land abrading the liner wall.
Pic 3 – Ship A (Inspection on 17th March 03)

The authors of this current paper would add that the occurrence of deposit on the top land (Pic 3) tends to be linked also with abrasion between the piston skirt and the liner wall. The deposit build up on the piston topland appears to be restricting free movement of the piston, possibly affecting the normal alignment of the piston. In these circumstances there is a scraping action of the piston skirt (Pic 4) against the liner wall disrupting the lubricant film and causing abrasive wear. In the period during 2002 and 2003 the authors have noted frequent occurrences in both MAN B&W and Sulzer engine designs.

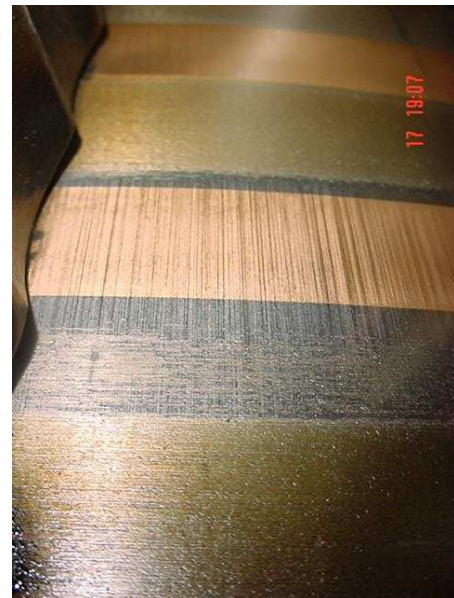
When wear does occur the high Iron in the CDO frequently corresponds with high Copper. This indicates abrasion between the piston skirt and liner wall as the piston beds in, and as the brass rubbing strip wears down. Chart 23 shows high Iron and Copper readings in Unit 4 at 151 hours following overhaul.

Initial wearing in of copper band on the piston skirt of Unit 4.
Pic 4 – Ship A (Inspection on 17th March 03)

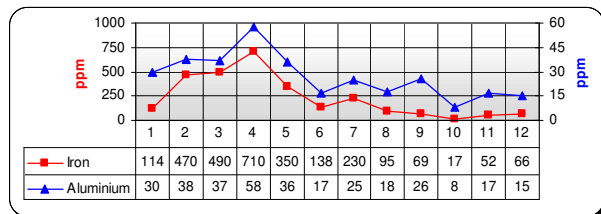
However, even Cat-fine content of 10 ppm Al "before ME Pump" as seen in the Fuel analysis in Chart 24, can cause abrasive wear. Chart 25 shows a close relationship between Iron and Aluminium when using the above Fuel, suggesting that Cat-fines are influencing wear in Units 1 to 7.

Cat-fines are influencing Iron ppm in Units 1 to 7.
Chart 25 – Ship A (18th February 03)
