PAPER NO.: 14

Investigations into Abrasive and Corrosive wear mechanisms of Pistons and Liners in large bore 2-stroke diesel engine cylinders

Terence McGeary, Flame Marine Ltd, United Kingdom
terence@flamemarine.com

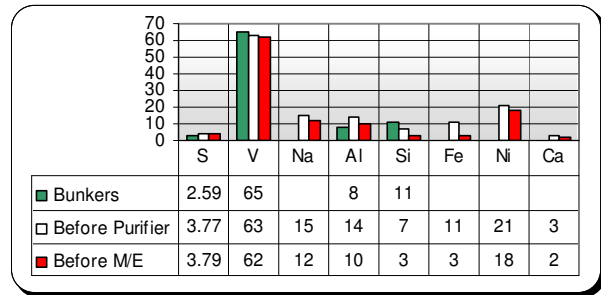
Fuel Analysis Comparison
Chart 24 – Ship A (18th February 03 samples)

However, even Cat-fine content of 10 ppm Al "before ME Pump" as seen in the Fuel analysis in Chart 24, can cause abrasive wear. Chart 25 shows a close relationship between Iron and Aluminium when using the above Fuel, suggesting that Cat-fines are influencing wear in Units 1 to 7.

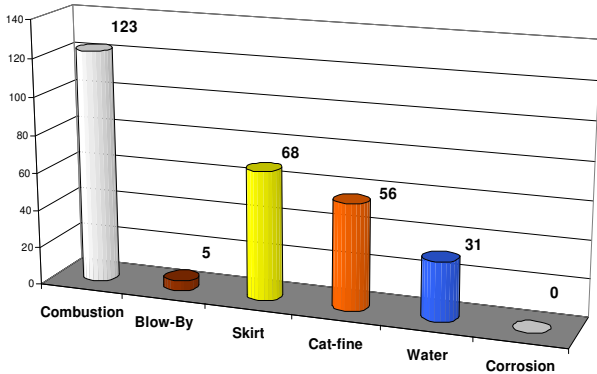
Chart 27 – Incidences of wear by type of wear and by cylinder on all 3 ships from total 672 drain oil samples

From a total of 672 CDO samples there were 283 samples showing increased wear.

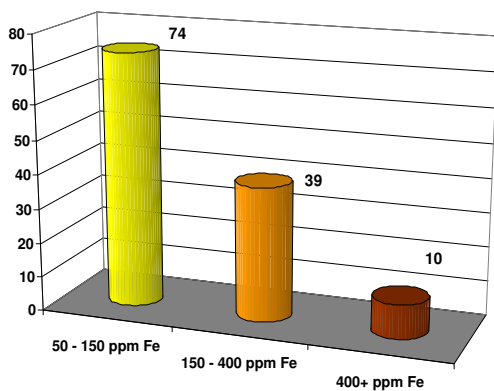
Chart 29 – Breakdown by degree of combustion related wear by cylinder for all 3 ships

Number of Incidences of Combustion related wear, broken down into “normal”, “high” and “unusual”.
